## **Monitoring of Streambank Stabilization and River Restoration Structures on Ice-Affected Rivers in Northern Vermont**

Andrew M. Tuthill

July 2009

Final report

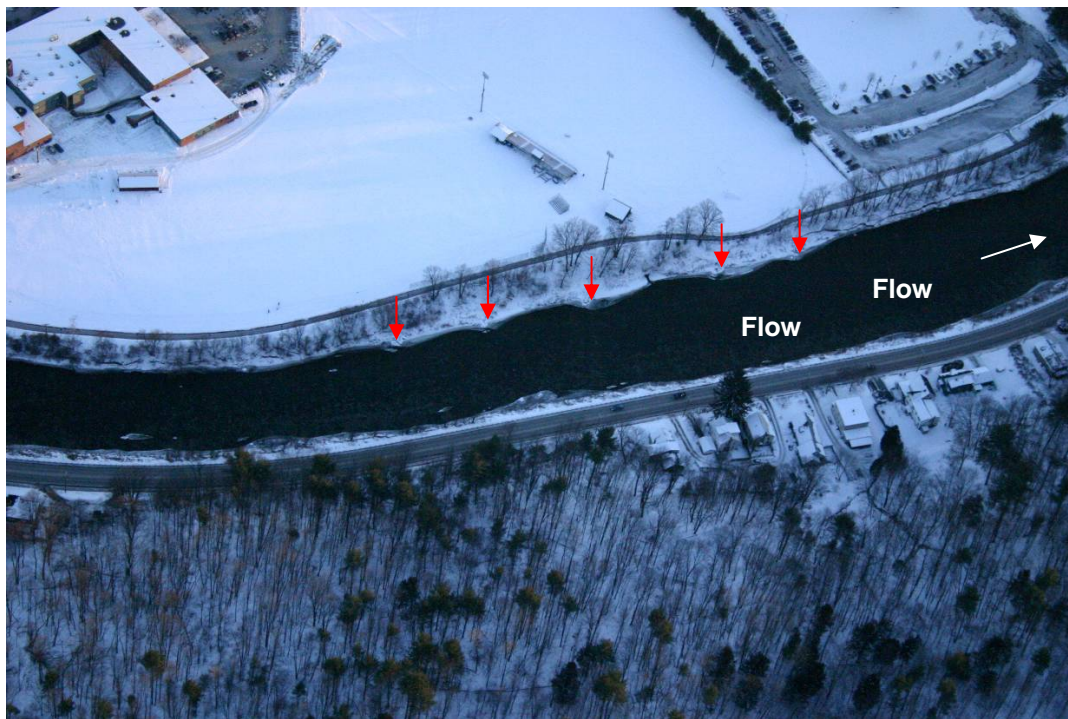
A series of five rock vanes were constructed in the Cemetery Bend reach of the Winooski River to stabilize the banks along the Montpelier High School playing fields (Figure 10). The vanes, which are spaced about one channel width apart, form about a 25° angle with the upstream bank and protrude into the river about 25 ft.

Figure 10. Rock vanes on the Winooski River at Montpelier, VT 12/21/05.

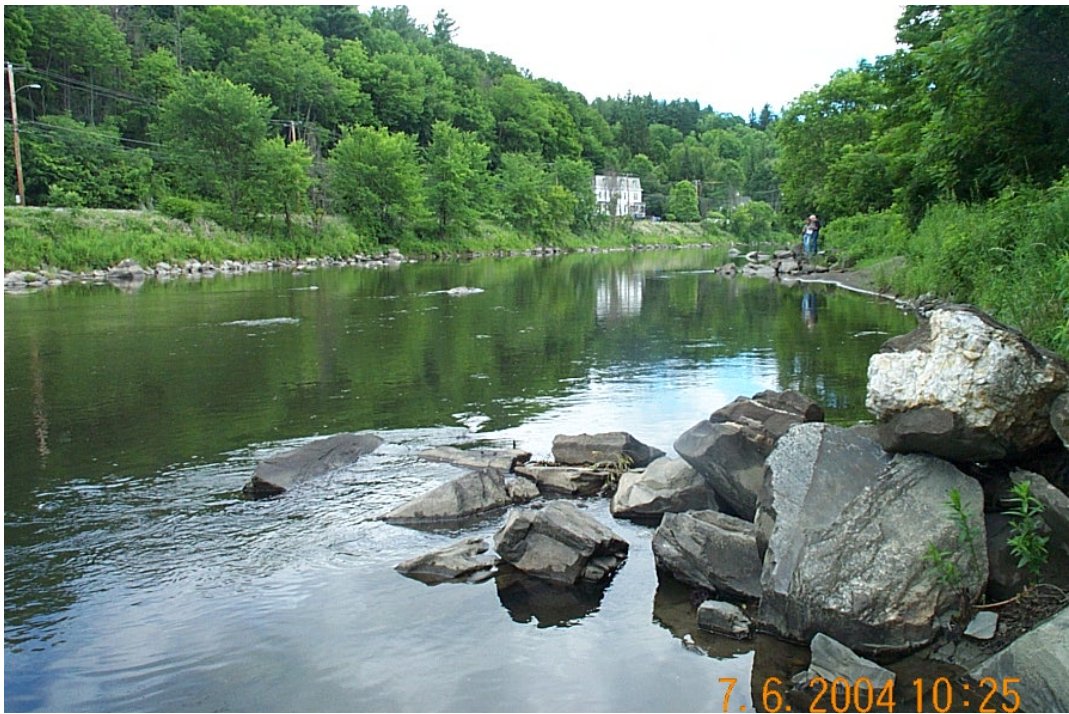
The randomly-placed rocks have an average diameter of about 1.5 ft. and a maximum diameter of about 2 ft. (Figure 11). The vanes tie into a narrow terrace at about half of the total bank height. Although the vane profiles represent only a small portion of the total cross sectional flow area, they effectively deflect flow away from the banks at normal flows and create zones of slower water in between, promoting sedimentation and the formation of stable sheet ice in winter (Figure 12).

Figure 11. Rock vanes on the Winooski River at Montpelier, VT viewed from downstream on 7/6/04.

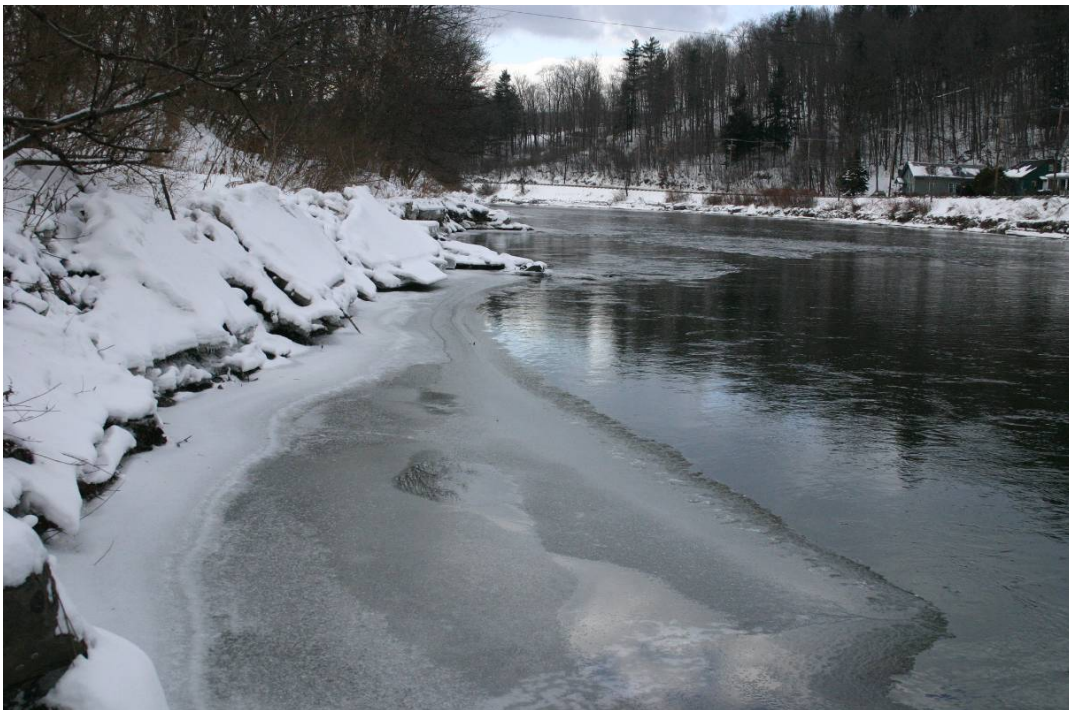
Figure 12. Rock vanes on the Winooski River at Montpelier, VT. viewed from upstream on 1/10/06.

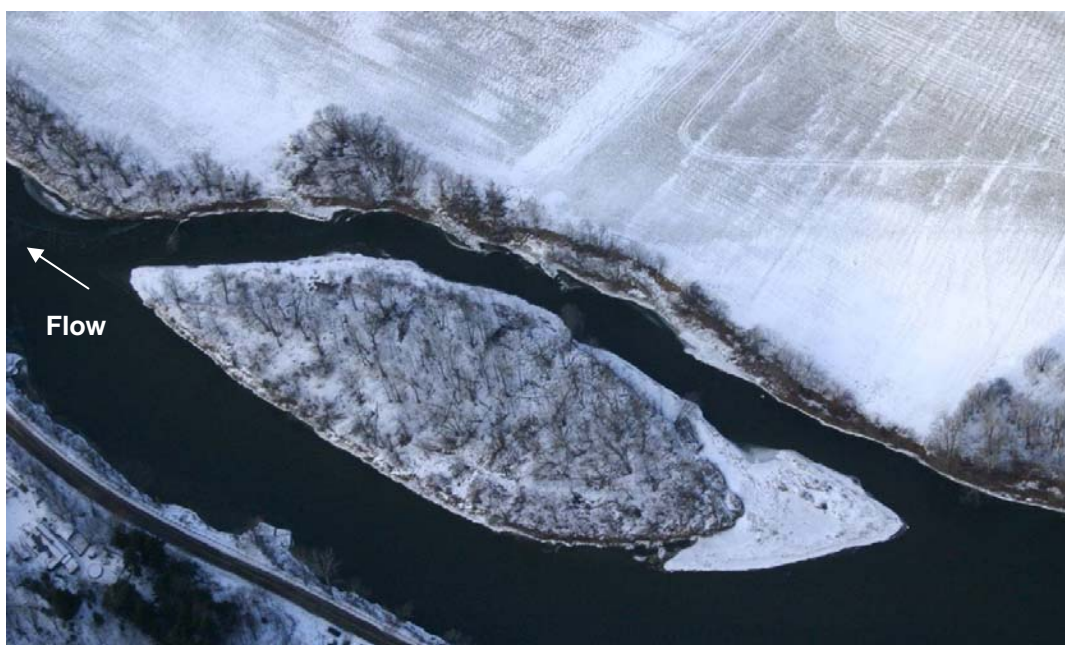
A photo taken during the freezeup period in January 2006 shows border ice forming around the vanes in patterns similar to the observed sedimentation (Figure 15). No dynamic ice breakups have occurred in this section of the Winooski since 2002, when the project was built. From the plan configuration of the channel, it appears that the breakup ice run would probably follow the main channel to the left of the island and not impact the structures directly. Another mitigating factor is the project location, about 3.5 miles downstream of the Bolton Falls Dam, which likely impedes the breakup ice run and lessens potential ice impacts to the structures.

Figure 15. Ice forming around rock vanes on the Winooski River, Fuller Farm, Bolton, VT 1/4/06.

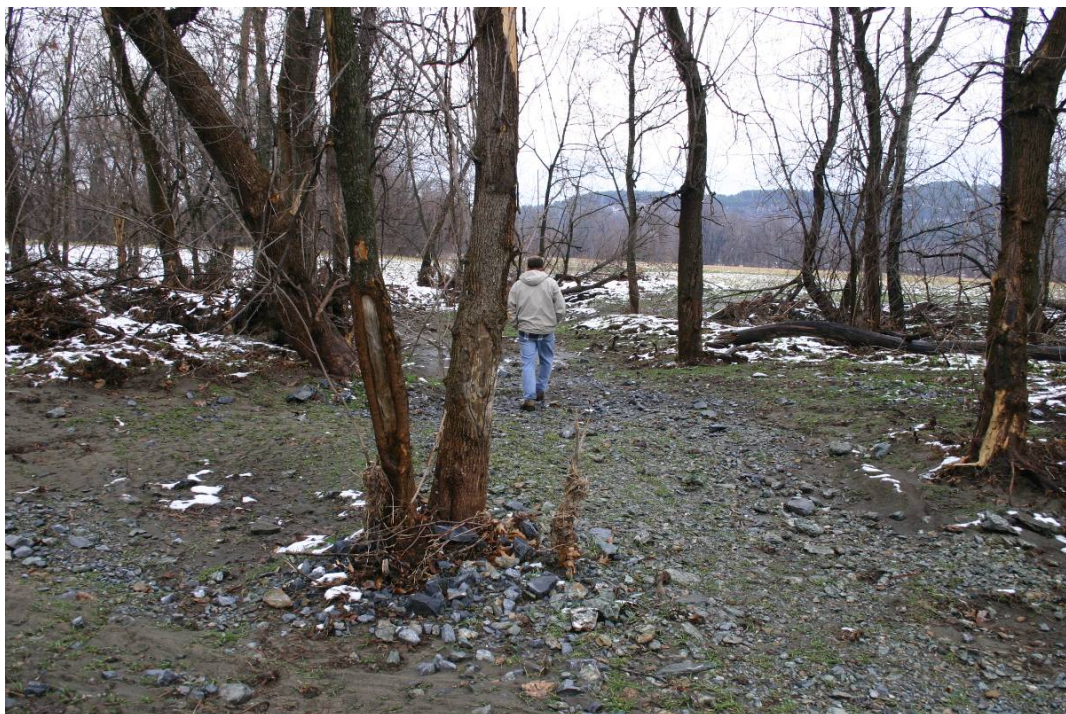
The trees in this area have been heavily scarred by ice to heights 5 ft. above the floodplain elevation (Figure 18) indicating heavy ice action in the past. This is not surprising since the 10 mile section of river from the Bolton Dam to Richmond Village is relatively straight with few features to impede the movement of breakup ice. Just downstream, the Snowflake Farm property lies in a transition zone into a wider valley with increased sinuosity and reduced slope. In light of these factors, one would expect heavy ice impacts at the Snowflake Farm site. As a result of the relatively mild environmental conditions of the recent series of winters, the project has not been tested by a severe ice event since its construction in 2003.

Figure 18. Entrance to flood chute at Snowflake Farm 11/28/05. Note tree scars due to ice.

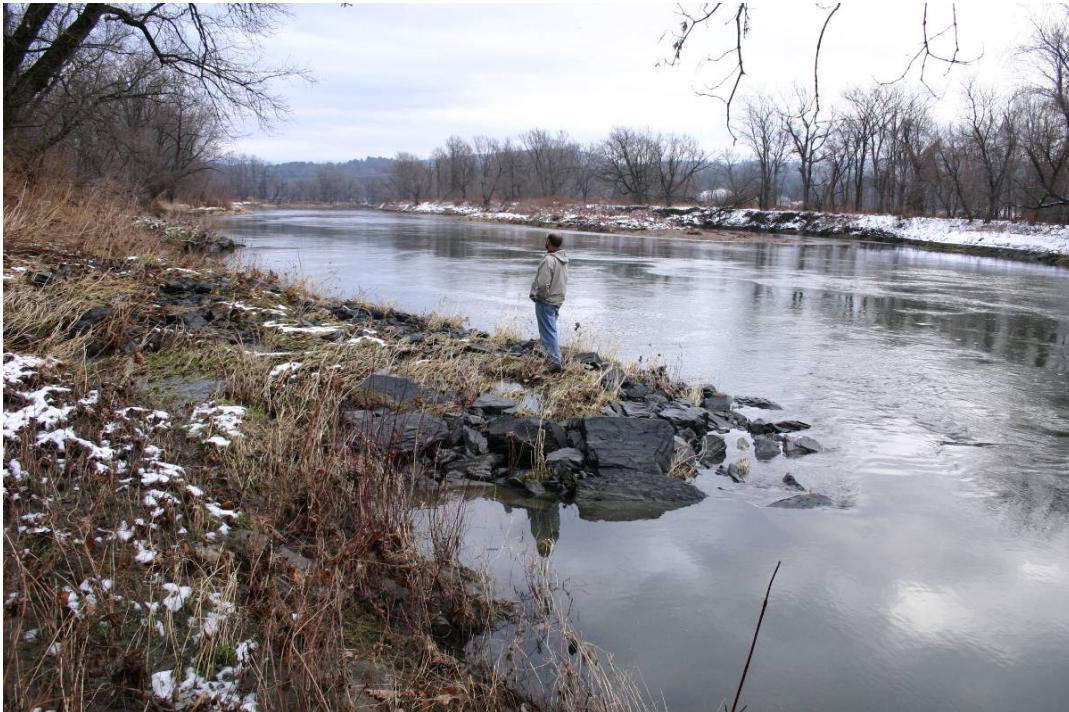
At the time of the 2 November 2005 visit, the Winooski discharge was up and the vanes were visibly diverting flow away from the banks, towards the channel center. On a 28 November 2005 visit, the water was lower, exposing randomly-placed riprap with an average diameter of about 12 inches (Figure 19).

Figure 19. Cross vanes on the Winooski River along Gov. Chittenden Rd. viewed from upstream on 11/28/05

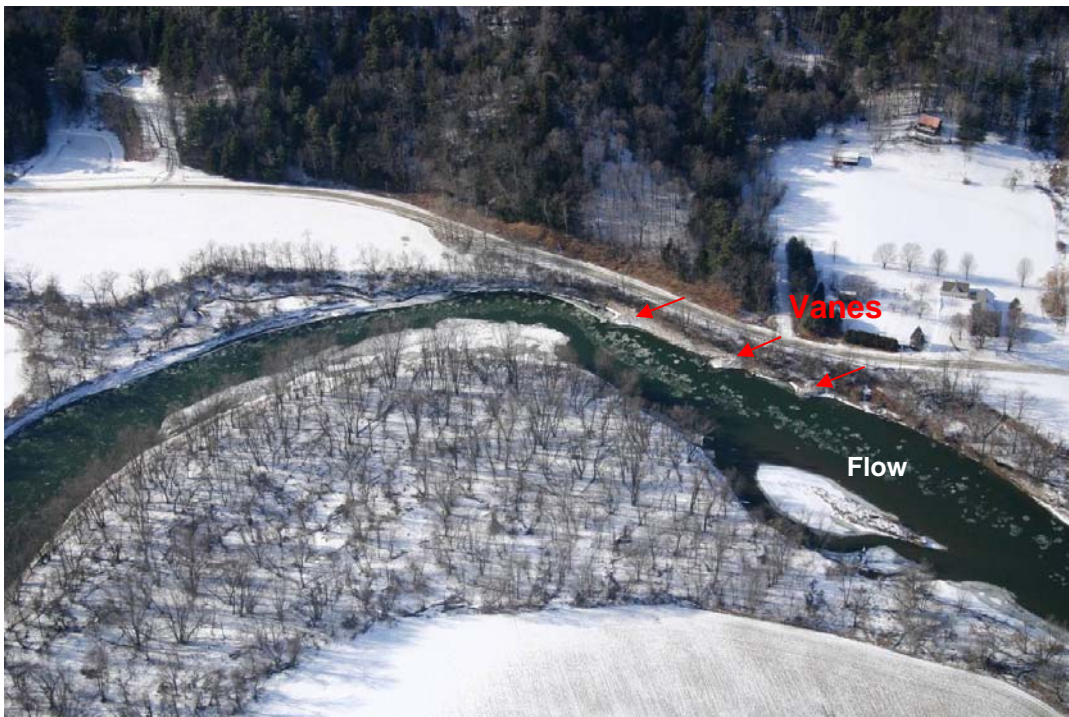
Figure 20. Drifting frazil ice and shore ice forming around vanes and on the Winooski, R. at Gov. Chittenden Rd. vanes, 1/31/08.

flyover show the vanes effectively deflecting drifting frazil pans towards the channel center (Figure 20). Judging from the upstream channel configuration, abundant tree scarring, and anecdotal accounts, the Gov. Chittenden site can experience significant ice action during the breakup period (Figure 21). No major ice events have occurred on this section of the Winooski in the eight years since the vanes were built however.

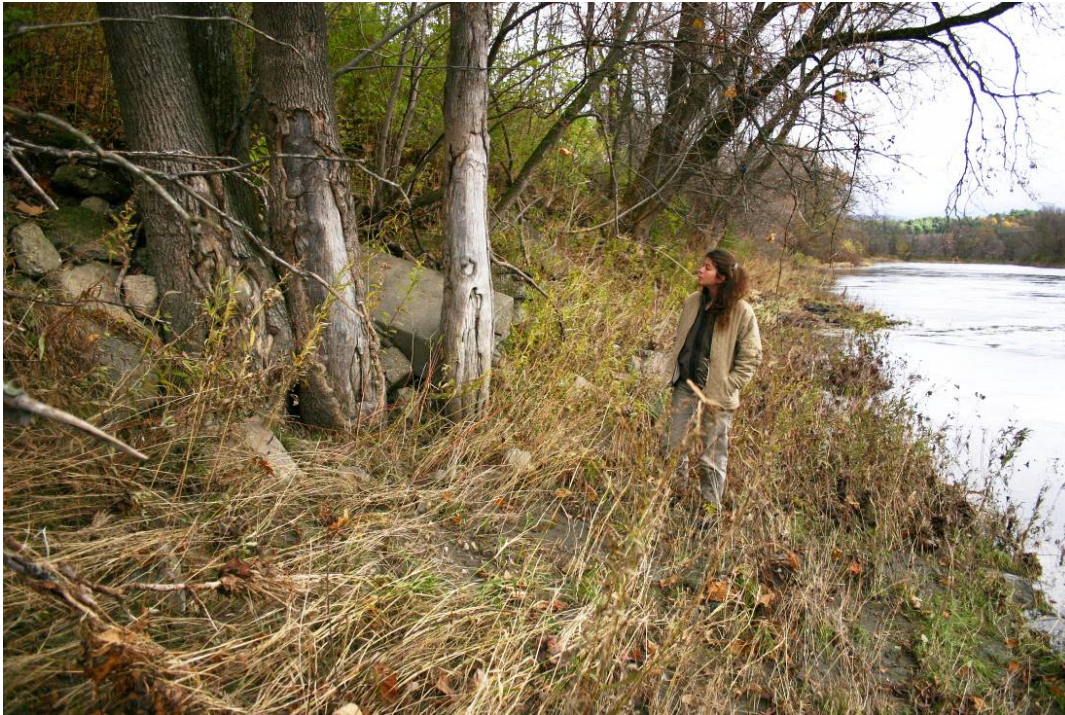
Figure 21. Heavy tree scarring by ice along Winooski, R. at Gov. Chittenden Rd. vanes, 11/2/05.

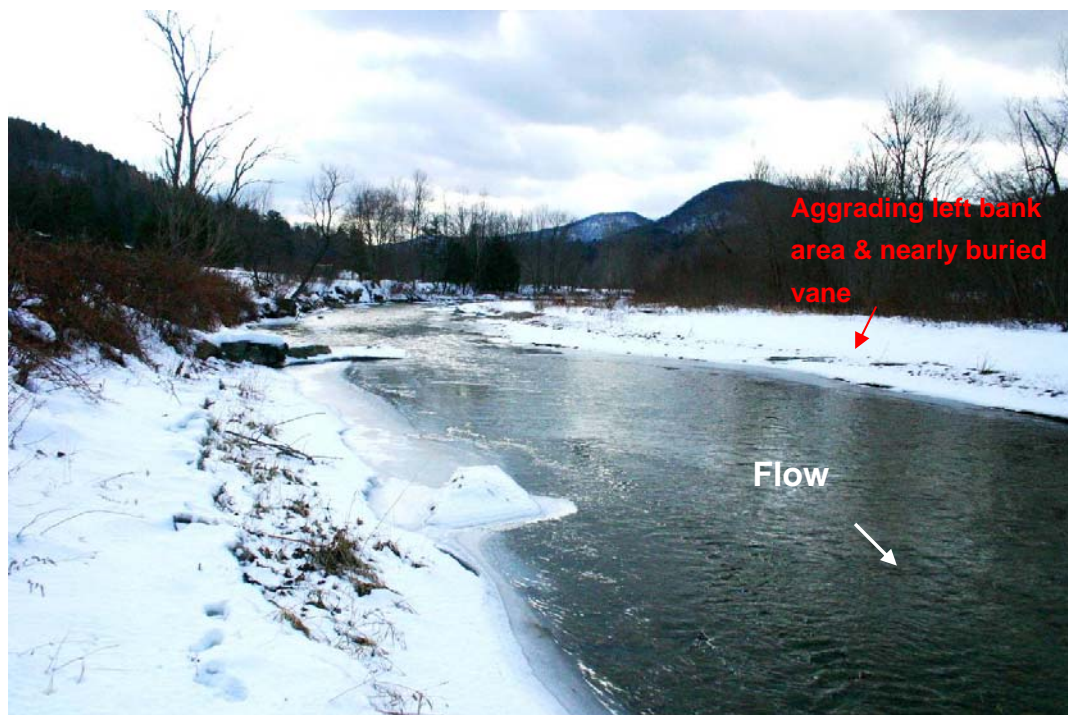
An aerial view on 10 January 2006 shows a continuous open lead along the path of fastest current. The lead narrows at the structures where border ice has formed around the vanes (Figure 23). It appears that the river is still aggrading in the vicinity of the upstream cross vane, as the rocks forming the left hand vane (facing downstream) are now nearly buried in gravel (Figure 24).

Figure 24. Mad River near Warren, upper cross vane viewed from downstream on 1/10/06. Note aggradation on the left bank (looking downstream) has nearly buried the vane.

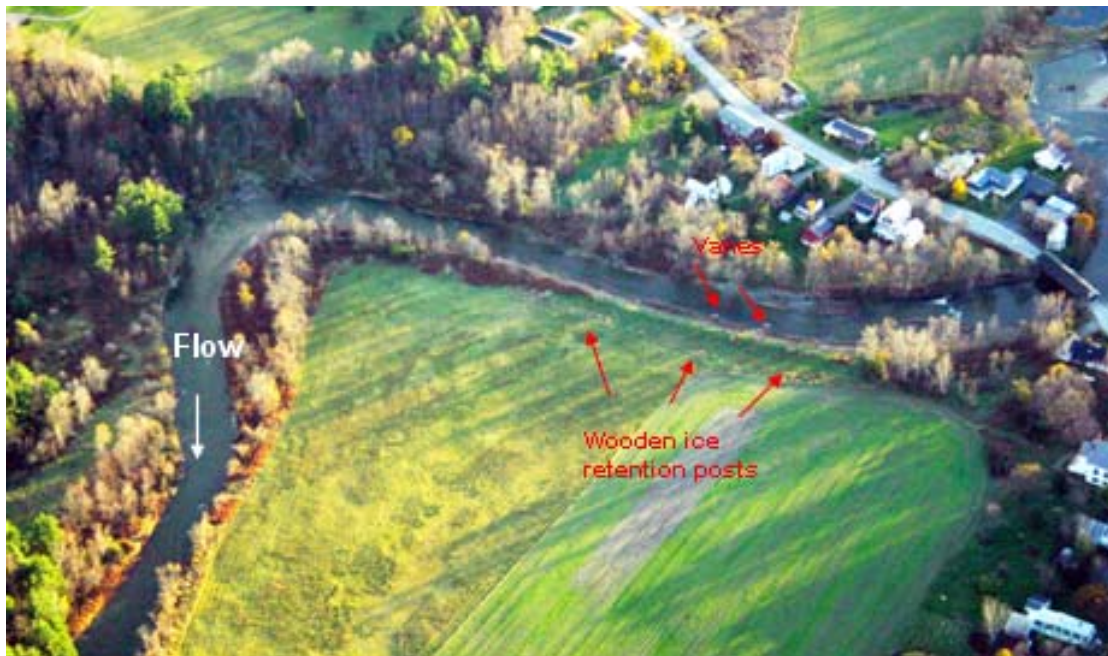
Several small rock vanes were constructed at least ten years ago to stabilize the left bank of the Mad River immediately below Waitsfield Village (Figure 25). The vanes tie into the bank well below the bankfull elevation and do not extend very far into the channel.

Figure 25. Mad River at Waitsfield: Site of two small rock vanes and ice retention posts. 11/2/05.

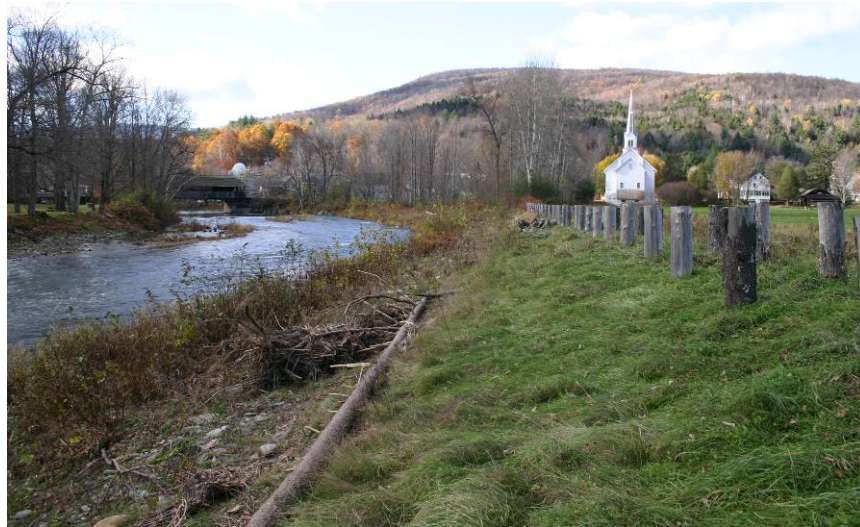
A double row of wooden posts lines the top of the bank to prevent debris and breakup ice from escaping into the adjacent field (Figure 26). At this point, the posts have started to rot and would probably not withstand an extreme ice event. On a 2 January 2005 visit, the rock vanes did not appear to be having much effect in terms of deflecting flow away from the shore. Several hundred yards downstream in a tight bend to the left, the river channel cuts into a clay bank, a large portion of which has slid into the river. This sharp bend is a possible breakup ice jam location. It could be that erosion and ice action since construction have diminished the original size of the rock vanes and decreased their effectiveness.

Figure 26. Mad River at Waitsfield: Ice retention posts 11/2/05.

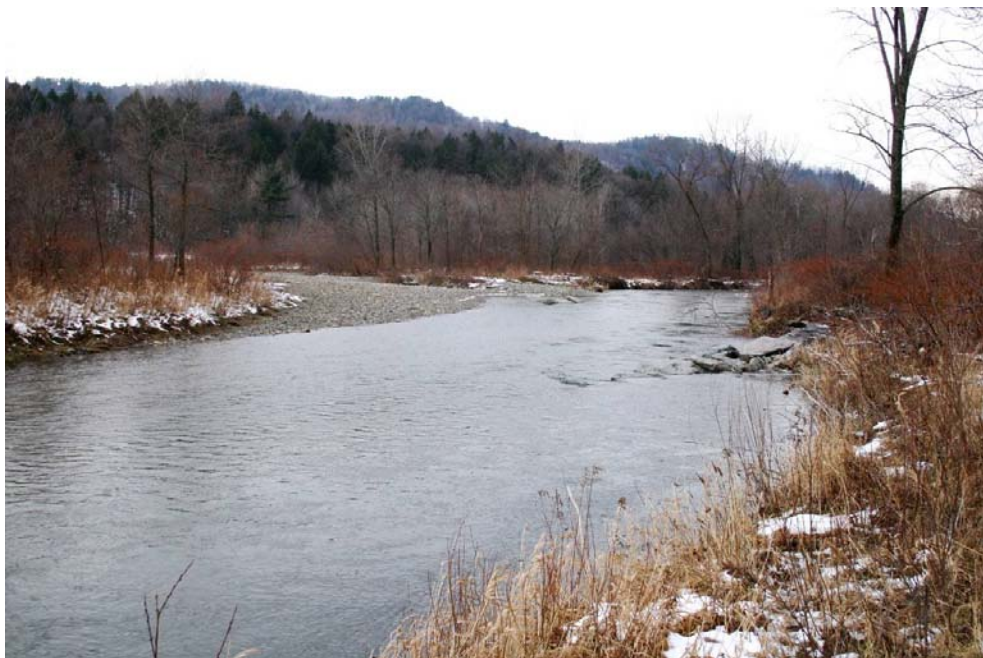
The project performed successfully for its first five years until an extreme flow event, on 17 October 2005, deposited a large volume of coarse bed material in the meander, causing a major avulsion into the blocked-off former channels to the right (Figures 30-34).

Figure 31. Gravel deposits in meander during October 2005 flood caused major avulsion to the right into former channel area. Photo taken 11/28/05.

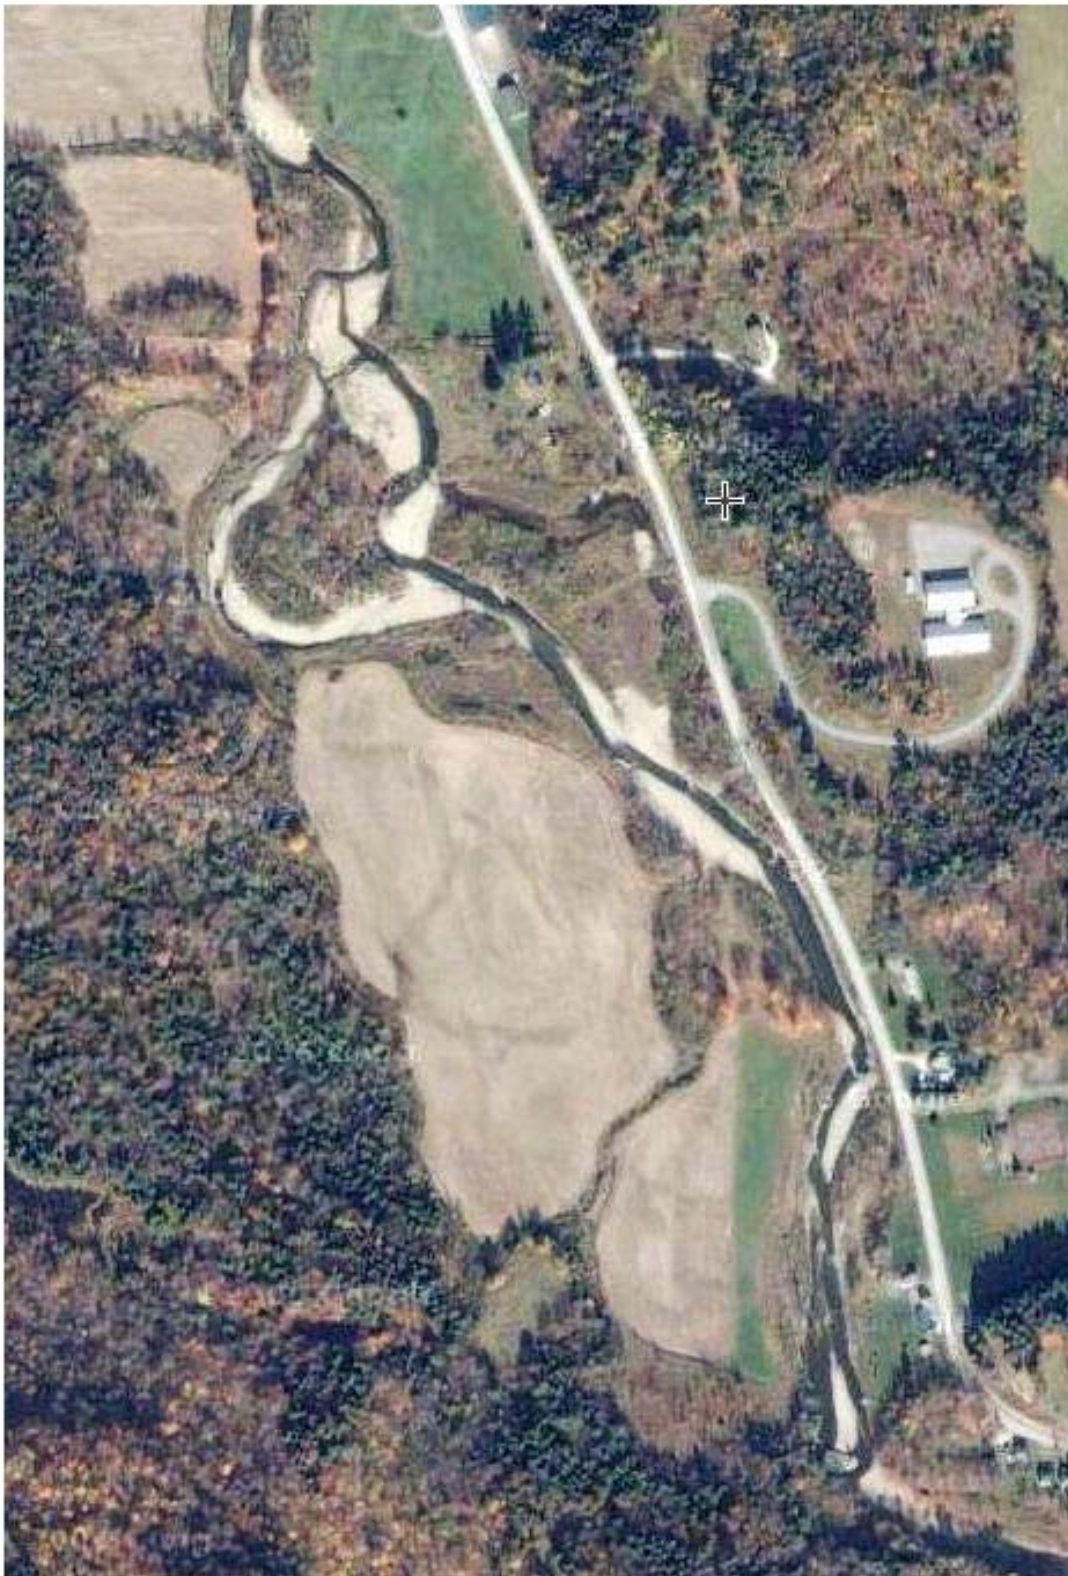
Figure 32. Recent air photo of Trout River restoration project below Montgomery Center. Deposition of coarse material in large meander during October 2005 flood caused a channel avulsion into the former channel area to the right.

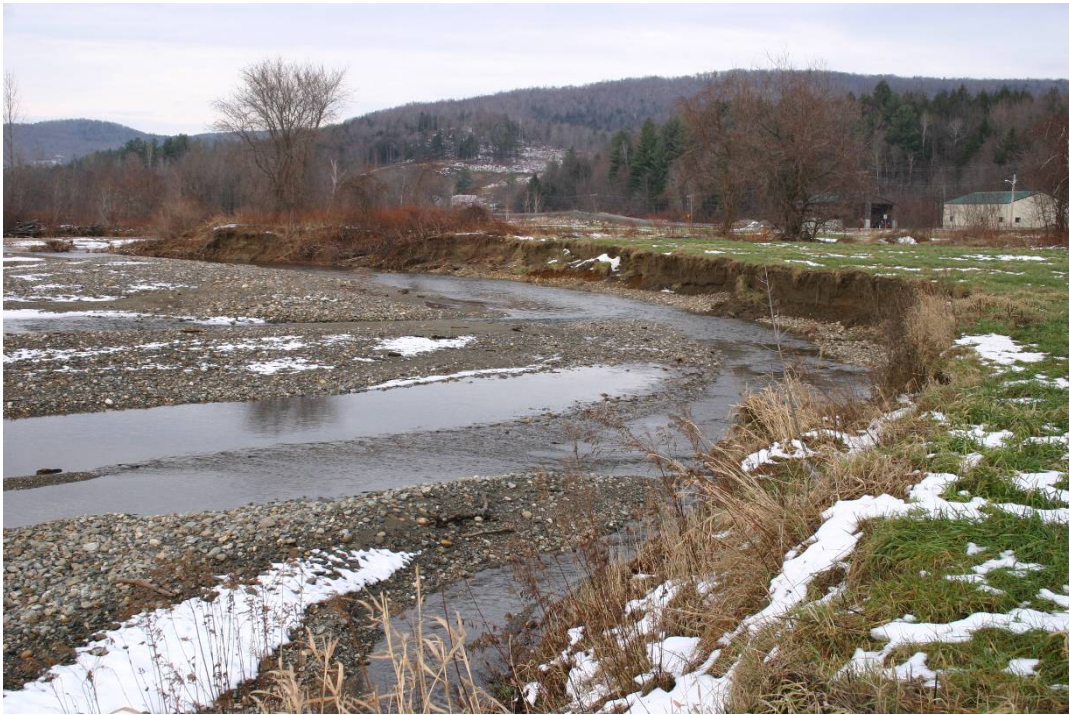
Figure 33. Trout River looking downstream at eroding bank on 11/28/09.

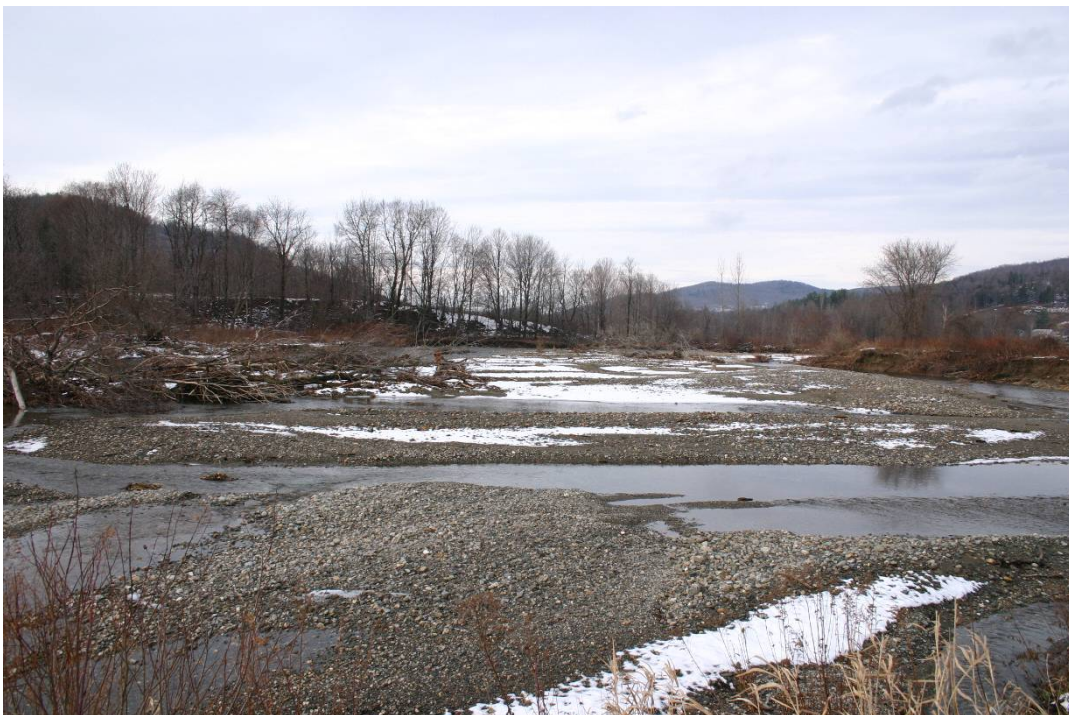
Figure 34. Trout River looking downstream at braided channels on 11/28/09.

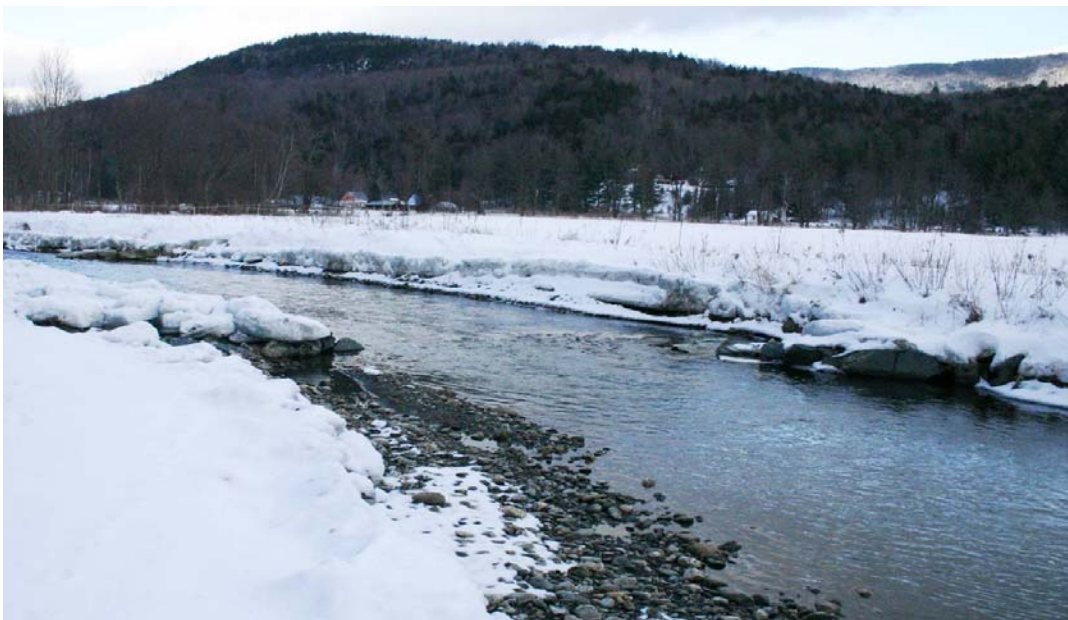
These two small streambank stabilization projects are located in the upper White River watershed. At the upstream project, near the village of Granville, the river banks have been stabilized by a series of small vanes and four cross vanes made of quarried rock. The project appears to be performing as designed in terms of bank stabilization and deposition. The structures had withstood a mild mid-winter breakup ice run just prior to a 10 January 2006 field visit (Figure 40).

Figure 40. Cross vane stabilizing banks of the White River below Granville, VT following mid-winter breakup 1/10/06.

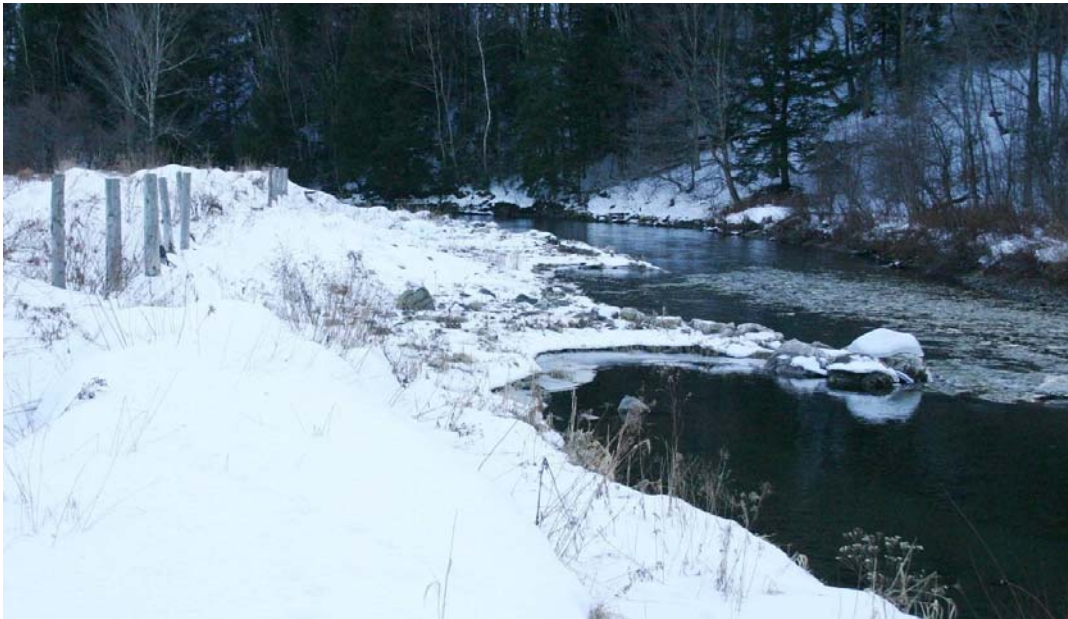
The downstream project, located above the village of Rochester, is similar, with vanes and cross vanes stabilizing the bank along the edge of a field (Figures 41 and 42). An earthen berm and a row of wooden posts have been constructed along the edge of the field with the likely purpose of preventing breakup ice from going out of bank during ice runs. The bank opposite the structures follows the edge of the valley and the structures appear to be resisting the natural tendency for the stream channel to cut the left bank and migrate into the field.

Figure 41. Vanes stabilizing bank of the White River above Rochester, VT. 1/10/06. Posts and berm to prevent ice from escaping into field of left.
